Cylinder Liner Cavitation Erosion

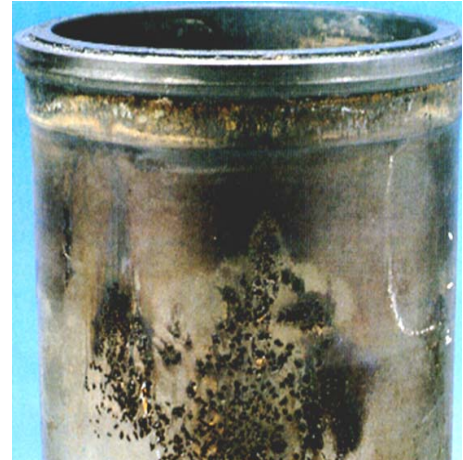
The affected areas form vertical strips or patches sometimes in alignment with the thrust face of the piston within the cylinder, or also formed immediately over the top sealing ring of the liner. The erosion can penetrate the wall of the cylinder and permit the flow of antifreeze/coolant to the oil or vice versa.

The cavitation erosion is caused by excess in harmonic vibrations of the engine and in some cases by loose fitting liners that result in a fast formation and implosion of small vapor bubbles within the coolant which attack the cylinders' liner wall. The vibration in combination with collapsing bubbles produces an erosive effect over the surface of the liner's exterior face. This occurs as the piston moves up and down within the cylinder causing vibration especially over the area of thrust in the cylinder liner. We can say that the wall of the sleeve, which comes in contact with the coolant, quickly moves inwards and outwards striking these vapor formations. During this process, tiny bubbles are formed that implode or collapse violently producing shock waves against the liner's wall. The results of these implosions at the impact area of the liner's wall have been calculated to reach over 10,000° F with pressures of over 10,000 psi.

Item 1: Eroded by cavitation zone

In many cases, cavitation can be avoided by reducing harmonic vibrations. For example, by making sure the injection complies with the manufacturer's specifications, the engine's speed is governed according to the manufacturer's data and that the control functions. Also, do not underestimate the importance of correct clearances between liner and cylinder blocks; incorrect liner fit is a serious contributor to liner vibration resulting in cavitation erosion.

Engine manufacturers have specific additives for the coolant called SCA (supplementary cooling additive). These additives will form a protective coating over the cylinder liner, which is exposed to the coolant, therefore reducing cavitation damage. With time, additive concentration reduces in the system, consequently making it necessary to follow system maintenance recommendations in order to keep the adequate levels. The following points will be supplied:
